**Flood Control Project Maintenance**  
**2018 Structure Summary Report**  
**Overall Unit and Item Ratings**

## Reclamation District No. 2096 Wetherbee Lake

### Wetherbee Lake Pumping Plant & Navigation Gate

**Flood Control Project Maintenance****Unit Cover Sheet****2018 Pumping Plant Inspection Results****Reclamation District No. 2096 Wetherbee Lake**

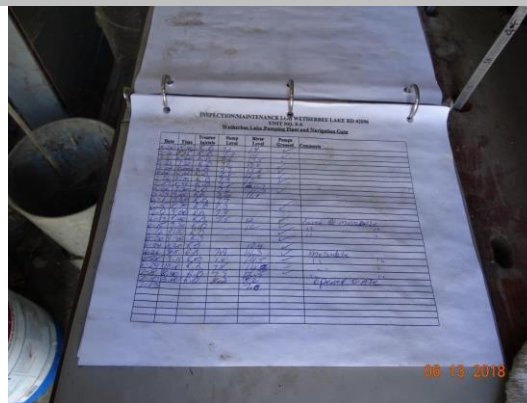
Photo 1 of 1 : ST\_2018\_RD2096\_56\_1\_20180618\_00024.jpg

LM Start	0.00	Rating **	A	Issue No.	1	
LM End	0.00	Issue Type +	Ma	Location *		
Category	Pump Stations			GPS Latitude/Longitude		
				Start	End	
Item	Operating Log			37.773864 °	37.773864 °	
				-121.298427 °	-121.298427 °	
DWR ID	DWR_RD2096_56_t_2012_1					
Action/Comments						
Inspector Comments: O&M log presented at time of inspection

View of the Operating Log.

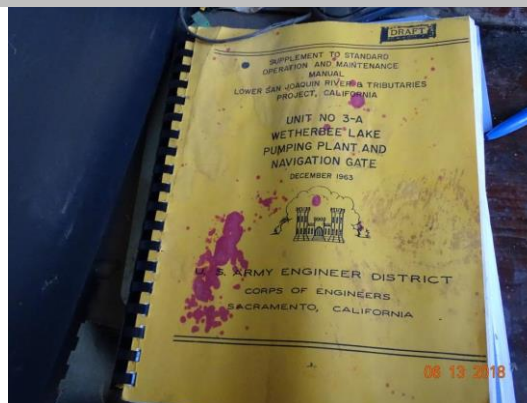
Photo 1 of 1 : ST\_2018\_RD2096\_56\_2\_20180618\_00025.jpg

LM Start	0.00	Rating **	A	Issue No.	2
LM End	0.00	Issue Type +	Ma	Location *	
Category	Pump Stations			GPS Latitude/Longitude	
				Start	End
Item	Operation & Maintenance Manual			37.773864 °	37.773864 °
				-121.298430 °	-121.298430 °
DWR ID	DWR_RD2096_56_t_2012_2				
Action/Comments					
Inspector Comments: O&M manual was present at time of inspection. LMA is in procees of creating posted operating instructions at pump station. L&M Manual does not mention instructions for operating the hand crank and running the gate in manual mode.

View of the O&amp;M Manual

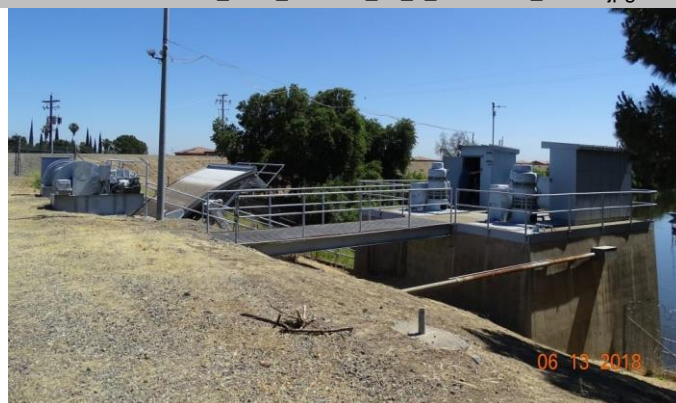
Photo 1 of 2 : ST\_2018\_RD2096\_56\_3\_20180618\_00026.jpg

LM Start	0.00	Rating **	A	Issue No.	3	
LM End	0.00	Issue Type +	Ma	Location *		
Category	Pump Stations			GPS Latitude/Longitude		
				Start	End	
Item	Plant Building			37.773864 °	37.773864 °	
				-121.298430 °	-121.298430 °	
DWR ID	DWR_RD2096_56_t_2012_3					
Action/Comments						
Inspector Comments: Building protects the controls only.

View of the plant building and radial gate

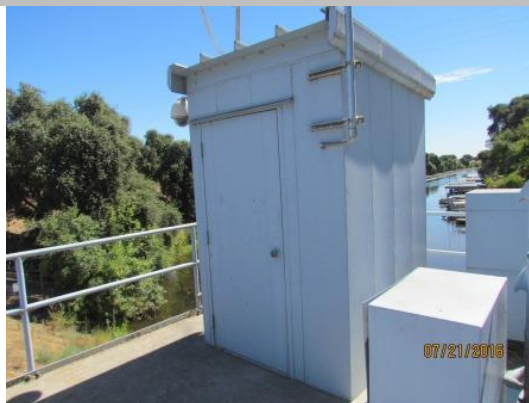
Photo 2 of 2 : ST\_2018\_RD2096\_56\_3\_20180608\_00004.jpg

LM Start	0.00	Rating **	A	Issue No.	3 (cont)	
LM End	0.00	Issue Type +	Ma	Location *		
Category	Pump Stations			GPS Latitude/Longitude		
				Start		End
Item	Plant Building			37.773864 °		37.773864 °
				-121.298430 °		-121.298430 °
DWR ID	DWR_RD2096_56_t_2012_3					
Action/Comments						
Inspector Comments: Building protects the controls only.

View of the floatwell instrument house

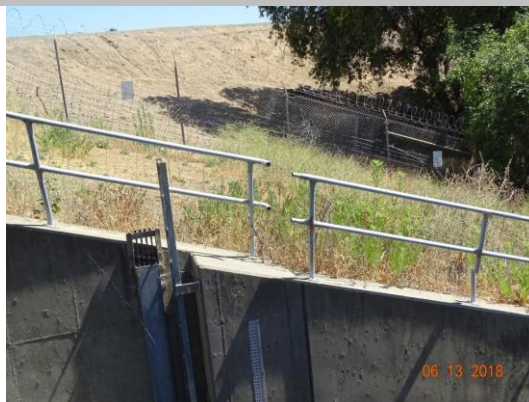
Photo 1 of 3 : ST\_2018\_RD2096\_56\_5\_20180618\_00035.jpg

LM Start	0.00	Rating **	M	Issue No.	5
LM End	0.00	Issue Type +	Ma	Location *	
Category	Pump Stations			GPS Latitude/Longitude	
				Start	End
Item	Safety			37.773864 °	37.773864 °
				-121.298430 °	-121.298430 °
DWR ID	DWR_RD2096_56_t_2012_5				
Action/Comments					
Inspector Comments: Missing guard rail on navigation canal. Missing fire extinguisher.

View of the missing rail on the north side of slough

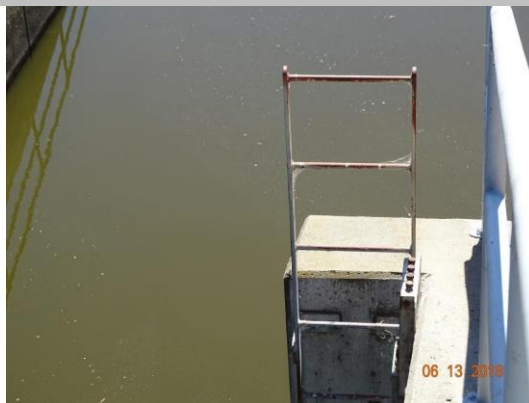
Photo 2 of 3 : ST\_2018\_RD2096\_56\_5\_20180618\_00033.jpg

LM Start	0.00	Rating **	M	Issue No.	5 (cont)	
LM End	0.00	Issue Type +	Ma	Location *		
Category	Pump Stations			GPS Latitude/Longitude		
				Start		End
Item	Safety			37.773864 °		37.773864 °
				-121.298430 °		-121.298430 °
DWR ID	DWR_RD2096_56_t_2012_5					
Action/Comments						
Inspector Comments: Missing guard rail on navigation canal. Missing fire extinguisher.

View of the escape ladder mounted on the south side of the canal

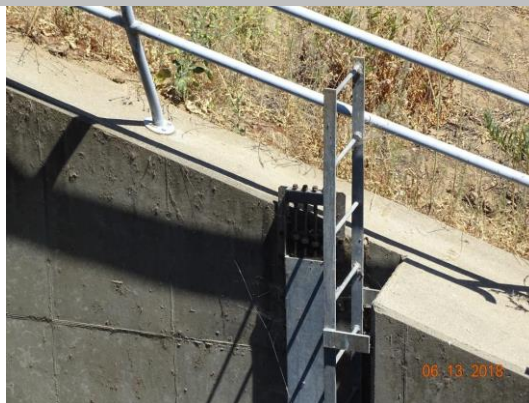
Photo 3 of 3 : ST\_2018\_RD2096\_56\_5\_20180618\_00037.jpg

View of the escape ladder mounted on the north side of the canal

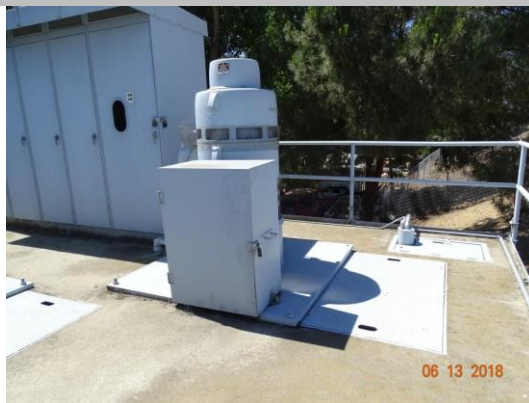
Photo 1 of 3 : ST\_2018\_RD2096\_56\_7\_20180618\_00027.jpg

LM Start	0.00	Rating **	A	Issue No.	7	
LM End	0.00	Issue Type +	Ma	Location *		
Category	Pump Stations			GPS Latitude/Longitude		
				Start	End	
Item	Pumps			37.773864 °	37.773864 °	
				-121.298430 °	-121.298430 °	
DWR ID	DWR_RD2096_56_t_2012_7					
Action/Comments						
Inspector Comments: Pumps appear to be in working order.

View of Pump 1

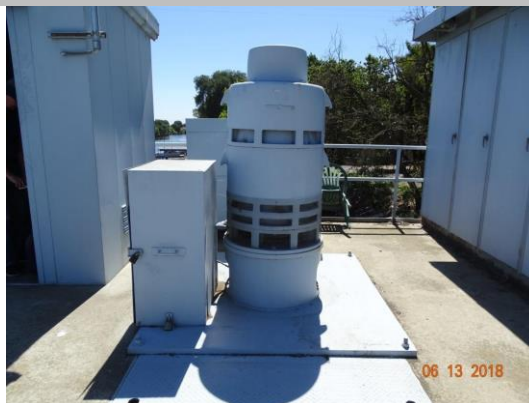
Photo 2 of 3 : ST\_2018\_RD2096\_56\_7\_20180618\_00028.jpg

View of Pump 2

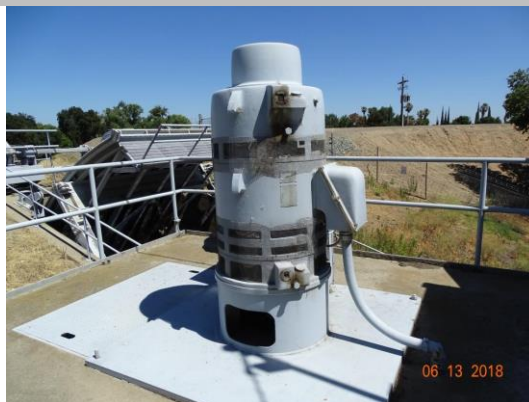
Photo 3 of 3 : ST\_2018\_RD2096\_56\_7\_20180618\_00029.jpg

View of Pump 3

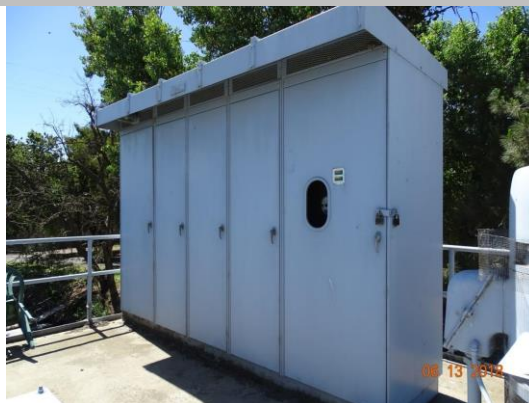
Photo 1 of 1 : ST\_2018\_RD2096\_56\_8\_20180618\_00030.jpg

LM Start	0.00	Rating **	A	Issue No.	8
LM End	0.00	Issue Type +	Ma	Location *	
Category	Pump Stations			GPS Latitude/Longitude	
				Start	End
Item	Power			37.773864 °	37.773864 °
				-121.298430 °	-121.298430 °
DWR ID	DWR_RD2096_56_t_2012_8				
Action/Comments					
Inspector Comments: No electrical deficiencies observed. Backup generators can be brought in on an emergency basis. However, an agreement to secure a generator during an emergency must be made. Debris inside the switchgear cabinet needs to be removed to prevent a fire hazard.

View of the electrical panel. Cobwebs and debris inside present a fire hazard.

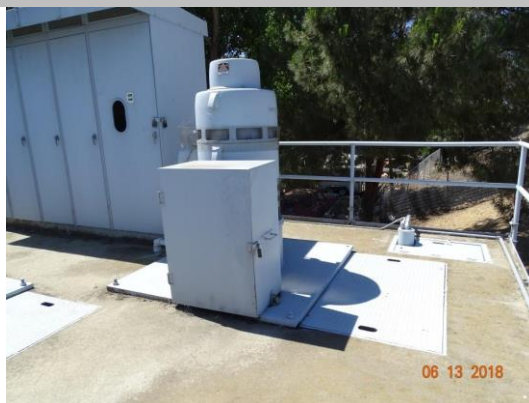
Photo 1 of 5 : ST\_2018\_RD2096\_56\_10\_20180618\_00038.jpg

LM Start	0.00	Rating **	M	Issue No.	10
LM End	0.00	Issue Type +	Ma	Location *	
Category	Pump Stations			GPS Latitude/Longitude	
				Start	End
Item	Motors, Engines, Fans & Gear Reducers			37.773864 °	37.773864 °
				-121.298430 °	-121.298430 °
DWR ID	DWR_RD2096_56_t_2012_10				
Action/Comments					
Inspector Comments: Missing some motor base nuts for at least Motors #1 and #3.

View of Motor 1

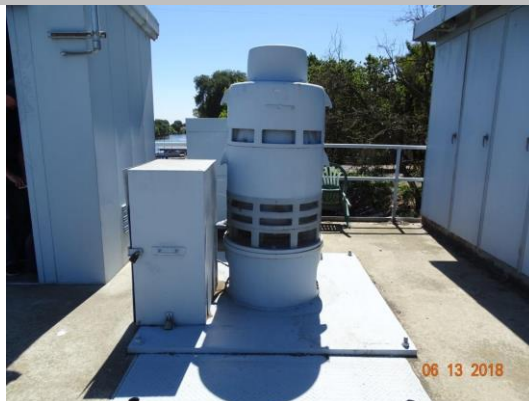
Photo 2 of 5 : ST\_2018\_RD2096\_56\_10\_20180618\_00039.jpg

View of Motor 2

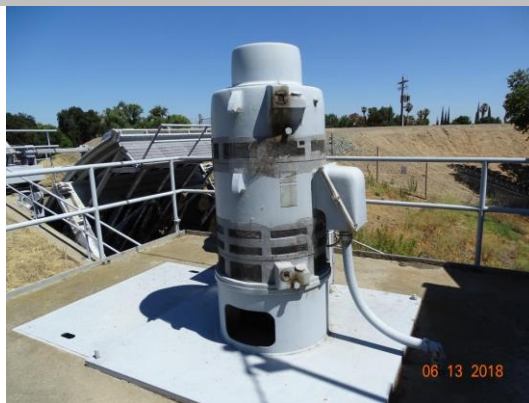
Photo 3 of 5 : ST\_2018\_RD2096\_56\_10\_20180618\_00040.jpg

LM Start	0.00	Rating **	M	Issue No.	10 (cont)	
LM End	0.00	Issue Type +	Ma	Location *		
Category	Pump Stations			GPS Latitude/Longitude		
				Start	End	
Item	Motors, Engines, Fans & Gear Reducers			37.773864 °	37.773864 °	
				-121.298430 °	-121.298430 °	
DWR ID	DWR_RD2096_56_t_2012_10					
Action/Comments						
Inspector Comments: Missing some motor base nuts for at least Motors #1 and #3.

View of Motor 3

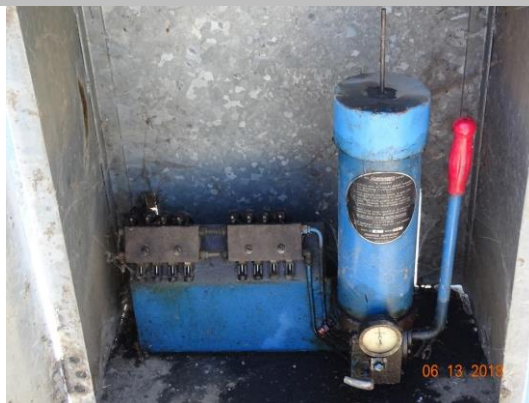
Photo 4 of 5 : ST\_2018\_RD2096\_56\_10\_20180618\_00042.jpg

View of the motor oiler

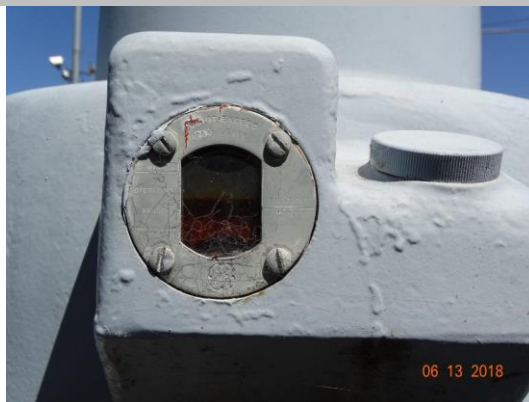
Photo 5 of 5 : ST\_2018\_RD2096\_56\_10\_20180618\_00041.jpg

View of the oil level in the motor

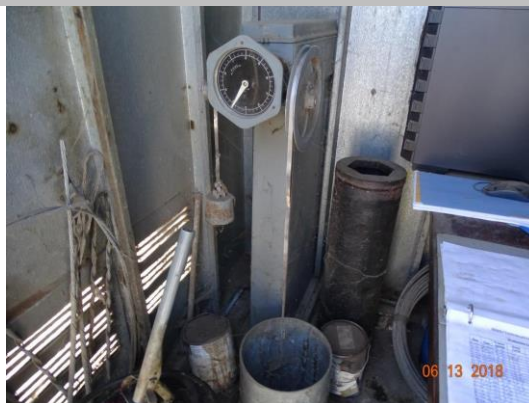
Photo 1 of 1 : ST\_2018\_RD2096\_56\_11\_20180618\_00043.jpg

LM Start	0.00	Rating **	A	Issue No.	11	
LM End	0.00	Issue Type +	Ma	Location *		
Category	Pump Stations			GPS Latitude/Longitude		
				Start	End	
Item	Pump Control Systems			37.773864 °	37.773864 °	
				-121.298430 °	-121.298430 °	
DWR ID	DWR_RD2096_56_t_2012_11					
Action/Comments						
Inspector Comments: Controls are free of damage and appear to operate normally.

View of the water level monitoring system that automatically controls the pumps.

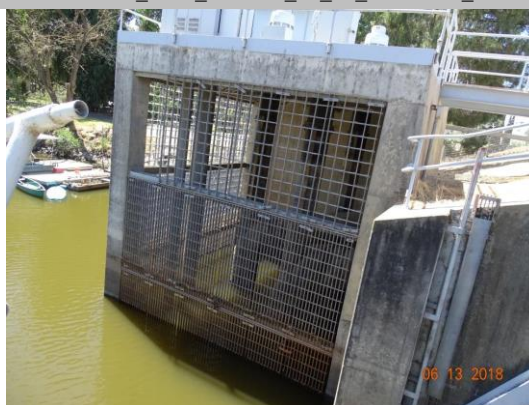
Photo 1 of 2 : ST\_2018\_RD2096\_56\_12\_20180618\_00045.jpg

LM Start	0.00	Rating **	A	Issue No.	12
LM End	0.00	Issue Type +	Ma	Location *	
Category	Pump Stations			GPS Latitude/Longitude	
				Start	End
Item	Sumps/Wet Well			37.773864 °	37.773864 °
				-121.298430 °	-121.298430 °
DWR ID	DWR_RD2096_56_t_2012_12				
Action/Comments					
Inspector Comments: Sump is clear of debris.

View of the pump intake system. Note the missing grate at top left corner.

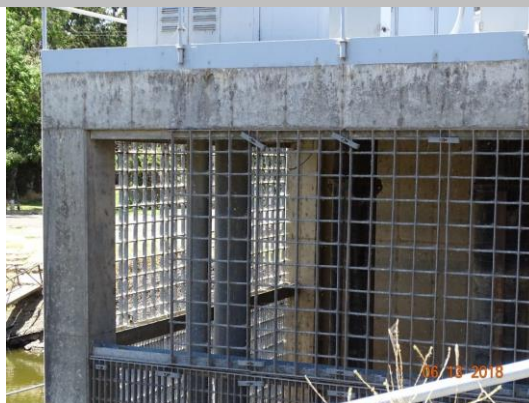
Photo 2 of 2 : ST\_2018\_RD2096\_56\_12\_20180618\_00044.jpg

View of the missing grate at top left corner

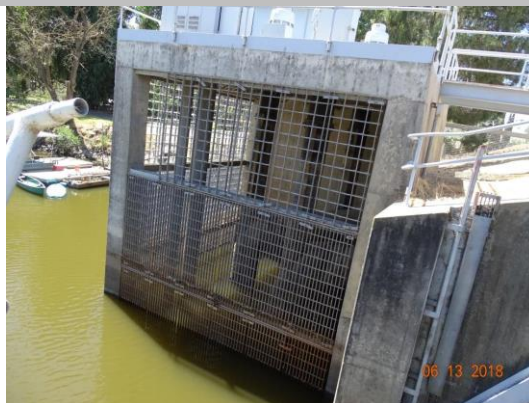
Photo 1 of 1 : ST\_2018\_RD2096\_56\_13\_20180618\_00046.jpg

LM Start	0.00	Rating **	M	Issue No.	13
LM End	0.00	Issue Type +	Ma	Location *	
Category	Pump Stations			GPS Latitude/Longitude	
				Start	End
Item	Trash Racks			37.773864 °	37.773864 °
				-121.298430 °	-121.298430 °
DWR ID	DWR_RD2096_56_t_2012_13				
Action/Comments					
Inspector Comments: Trash rack is present, however one panel is missing from rack.

A section of the trash rack is missing in the upper left part of the photo.

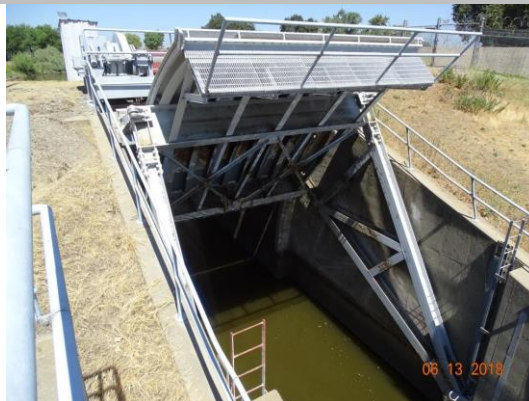
Photo 1 of 3 : ST\_2018\_RD2096\_56\_16\_20180618\_00047.jpg

LM Start	0.00	Rating **	A	Issue No.	16
LM End	0.00	Issue Type +	Ma	Location *	
Category	Pump Stations			GPS Latitude/Longitude	
				Start	End
Item	Electric Gate Operators			37.773864 °	37.773864 °
				-121.298430 °	-121.298430 °
DWR ID	DWR_RD2096_56_t_2012_16				
Action/Comments					
Inspector Comments: Item appears to be in good working condition. Radial arm gate was open at time of inspection.

View of the radial arm gate in the open position.

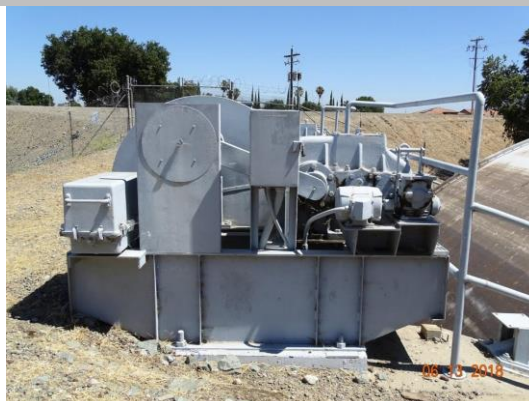
Photo 2 of 3 : ST\_2018\_RD2096\_56\_16\_20180618\_00048.jpg

View of the gate hoist assembly

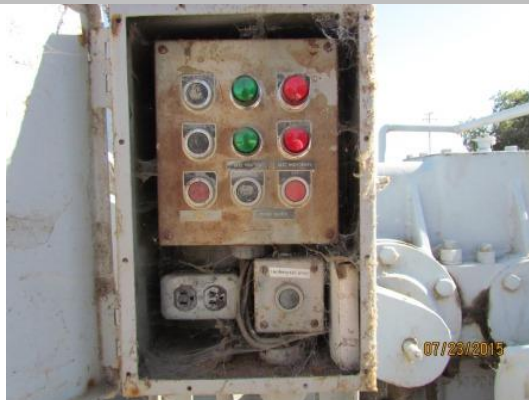
Photo 3 of 3 : ST\_2018\_RD2096\_56\_16\_20180608\_00016.jpg

View of the gate control station

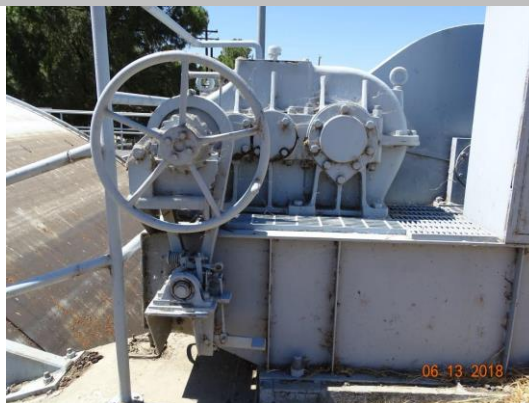
Photo 1 of 2 : ST\_2018\_RD2096\_56\_17\_20180618\_00049.jpg

LM Start	0.00	Rating **	U	Issue No.	17
LM End	0.00	Issue Type +	Ma	Location *	
Category	Pump Stations			GPS Latitude/Longitude	
				Start	End
Item	Manual Gate Operators			37.773864 °	37.773864 °
				-121.298430 °	-121.298430 °
DWR ID	DWR_RD2096_56_t_2012_17				
Action/Comments					
Inspector Comments: The manual gate operator has not been tested, and the foot brake is inoperable.

View of manual gate operator

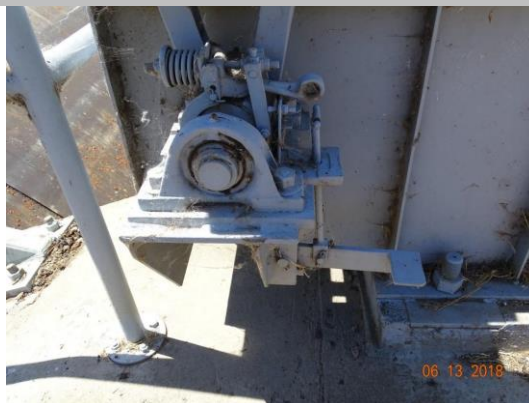
Photo 2 of 2 : ST\_2018\_RD2096\_56\_17\_20180618\_00050.jpg

View of foot brake for manual gate operator. Note missing components.

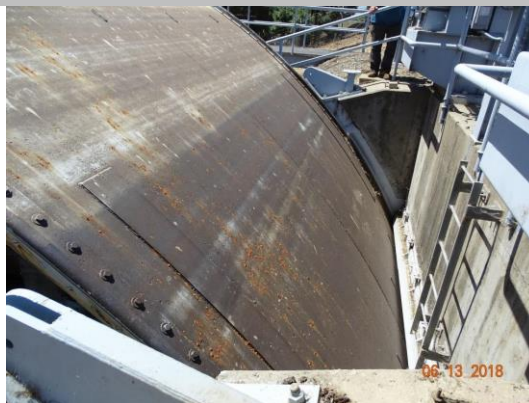
Photo 1 of 1 : ST\_2018\_RD2096\_56\_18\_20180618\_00059.jpg

LM Start	0.00	Rating **	A	Issue No.	18
LM End	0.00	Issue Type +	Ma	Location *	
Category	Pump Stations			GPS Latitude/Longitude	
				Start	End
Item	Other Metallic Items			37.773864 °	37.773864 °
				-121.298430 °	-121.298430 °
DWR ID	DWR_RD2096_56_t_2012_18				
Action/Comments					
Inspector Comments: Metal surfaces may need painting in the near future.

View of corrosion on radial gate

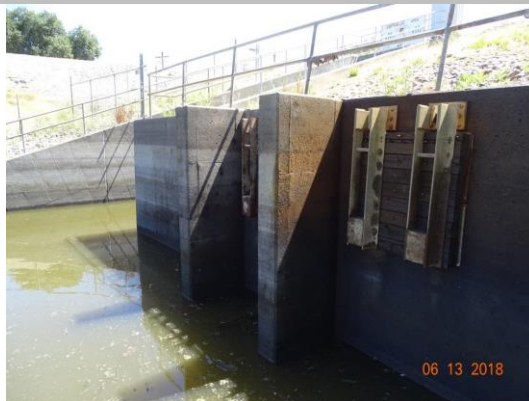
Photo 1 of 1 : ST\_2018\_RD2096\_56\_19\_20180618\_00051.jpg

LM Start	0.00	Rating **	A	Issue No.	19
LM End	0.00	Issue Type +	Ma	Location *	
Category	Pump Stations			GPS Latitude/Longitude	
				Start	End
Item	Flap Gates			37.773864 °	37.773864 °
				-121.298430 °	-121.298430 °
DWR ID	DWR_RD2096_56_t_2012_19				
Action/Comments					
Inspector Comments: Flap gates appear to be fully operational.

View of the flapgates

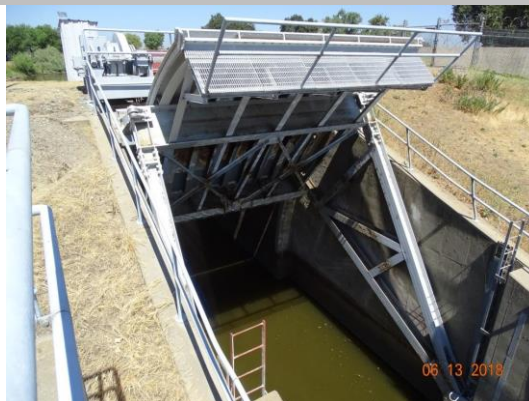
Photo 1 of 2 : ST\_2018\_RD2096\_56\_20\_20180618\_00053.jpg

LM Start	0.00	Rating **	A	Issue No.	20
LM End	0.00	Issue Type +	Ma	Location *	
Category	Pump Stations			GPS Latitude/Longitude	
				Start	End
Item	Closure Structures			37.773864 °	37.773864 °
				-121.298430 °	-121.298430 °
DWR ID	DWR_RD2096_56_t_2012_20				
Action/Comments					
Inspector Comments: Radial arm gate acts as closure structure, gate was open at time of inspection.

View of radial arm gate, shown in open position

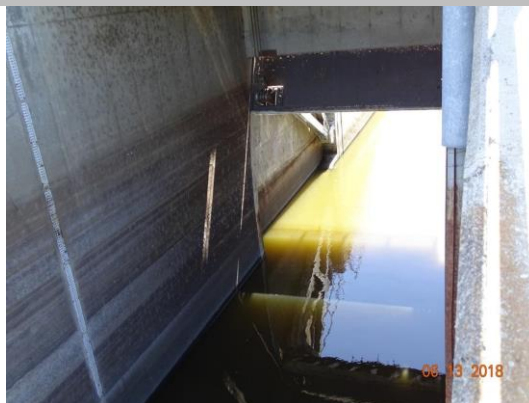
Photo 2 of 2 : ST\_2018\_RD2096\_56\_20\_20180618\_00054.jpg

View of radial arm gate in the open position

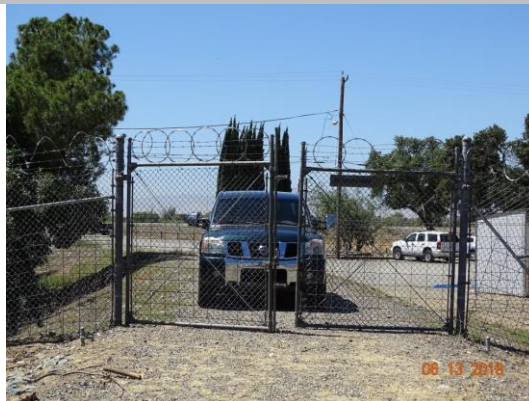
Photo 1 of 4 : ST\_2018\_RD2096\_56\_21\_20180618\_00056.jpg

LM Start	0.00	Rating **	M	Issue No.	21
LM End	0.00	Issue Type +	Ma	Location *	
Category	Pump Stations			GPS Latitude/Longitude	
				Start	End
Item	Security Fencing			37.773864 °	37.773864 °
				-121.298430 °	-121.298430 °
DWR ID	DWR_RD2096_56_t_2012_21				
Action/Comments					
Inspector Comments: Security fencing is in place. Closed circuit cameras are also in place. Tree debris needs to be removed from fencing at south east side of compound.

View of the security fencing at the main gate

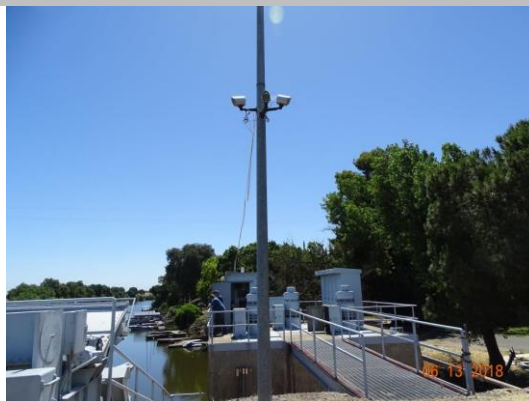
Photo 2 of 4 : ST\_2018\_RD2096\_56\_21\_20180618\_00055.jpg

View of the security cameras at the facility

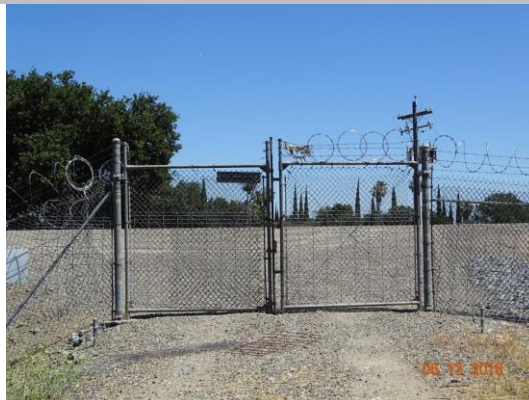
Photo 3 of 4 : ST\_2018\_RD2096\_56\_21\_20180618\_00057.jpg

View of the security fencing around the facility

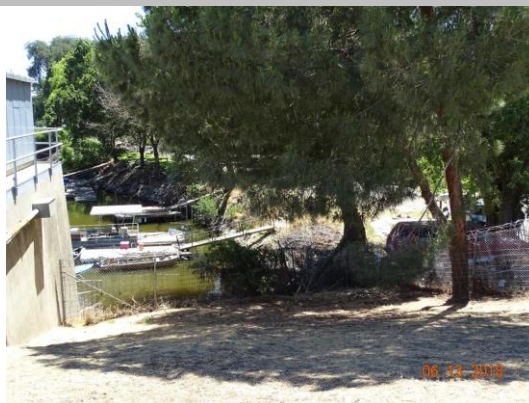
Photo 4 of 4 : ST\_2018\_RD2096\_56\_21\_20180629\_00060.jpg

LM Start	0.00	Rating **	M	Issue No.	21 (cont)	
LM End	0.00	Issue Type +	Ma	Location *		
Category	Pump Stations			GPS Latitude/Longitude		
				Start	End	
Item	Security Fencing			37.773864 °	37.773864 °	
				-121.298430 °	-121.298430 °	
DWR ID	DWR_RD2096_56_t_2012_21					
Action/Comments						
Inspector Comments: Security fencing is in place. Closed circuit cameras are also in place. Tree debris needs to be removed from fencing at south east side of compound.

View of the fencing on upstream side. Tree debris needs to be removed from fence.

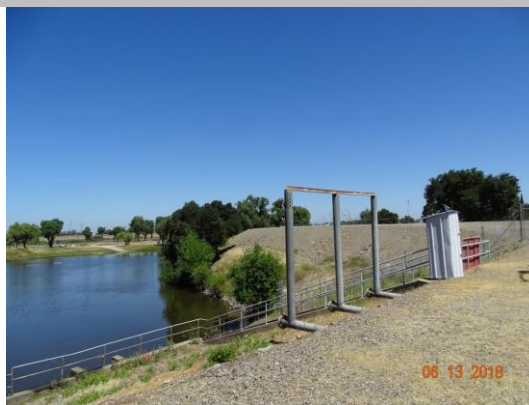
Photo 1 of 1 : ST\_2018\_RD2096\_56\_22\_20180618\_00058.jpg

LM Start	0.00	Rating **	A	Issue No.	22
LM End	0.00	Issue Type +	Ma	Location *	
Category	Pump Stations			GPS Latitude/Longitude	
				Start	End
Item	Intake and Discharge Pipes			37.773864 °	37.773864 °
				-121.298430 °	-121.298430 °
DWR ID	DWR_RD2096_56_t_2012_22				
Action/Comments					
Inspector Comments: Pipes appear to be free of defects.

View of the siphon breakers at the levee crown
